# Application Note

Title: Metal Stamped Part Inspection with Cognex 3G7

No. VS 504

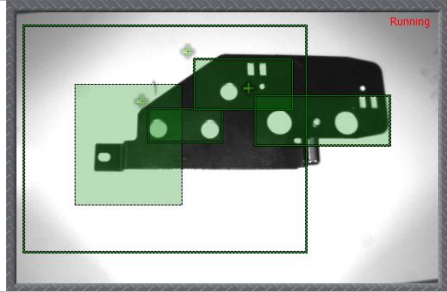
The leading edge of the part is located and three Pattern Tools are applied to detect the correct perforations on each stamped part:

All **Green Boxes** indicate a **PASSED** Inspection  
Good Part

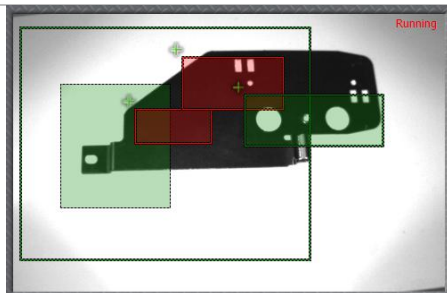
The leading edge of the part is located and two of the Pattern Tools Fail:

Pattern 1: 2 Holes missing **Red Box**  
Pattern 2: 1 Hole missing **Red Box**  
Pattern 3: All holes present **Green Box**  
**FAILED** Inspection  
Bad Part

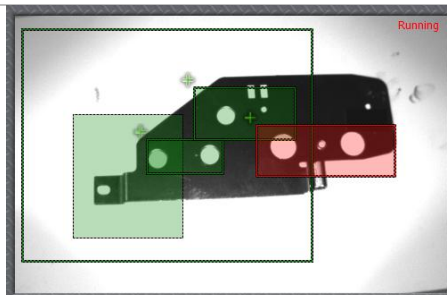
The leading edge of the part is located and one of Pattern Tools Fail:

Pattern 1: All holes present **Green Box**  
Pattern 2: All holes present **Green Box**  
Pattern 3: 2 rectangular boxes missing **Red Box**  
**FAILED** Inspection  
Bad part

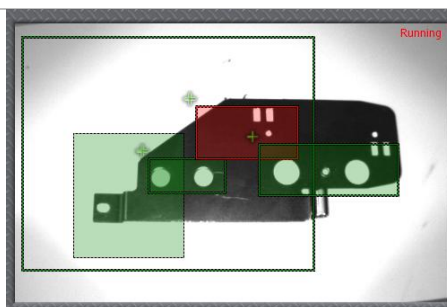
The leading edge of the part is located and one of the Pattern Tools Fail:

Pattern 1: All holes present **Green Box**  
Pattern 2: 1 hole missing **Red Box**  
Pattern 3: All holes present **Green Box**  
**FAILED** Inspection  
Bad part
